***CONTAMINATION
OBSERVATIONS
& ANALYSIS***

***MEEP
Polished Plate Meteoroid
and Debris Experiment***

SEE Flight Experiments Workshop

June 23-25, 1998

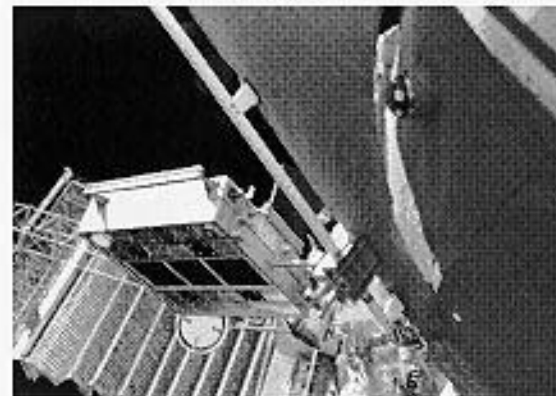
4. Opened PEC with exposed experiment test specimens clamped to handrail on Mir Orbiter Docking Adapter. (EVA operation)

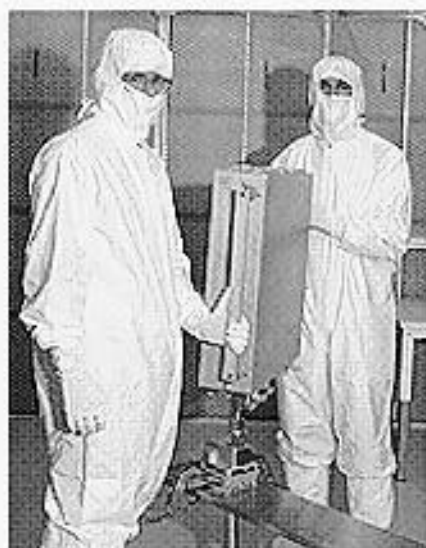
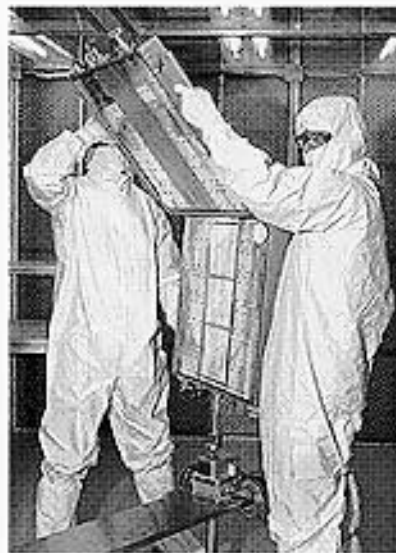
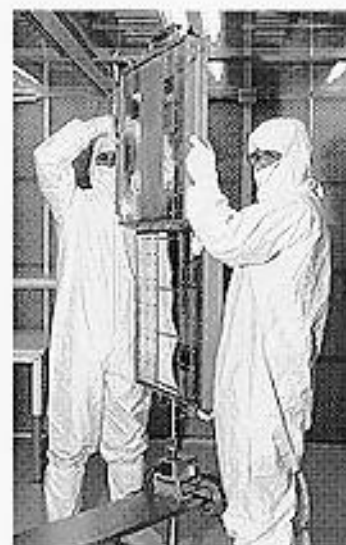
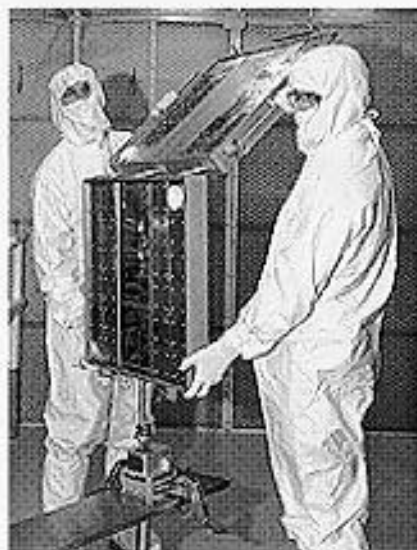
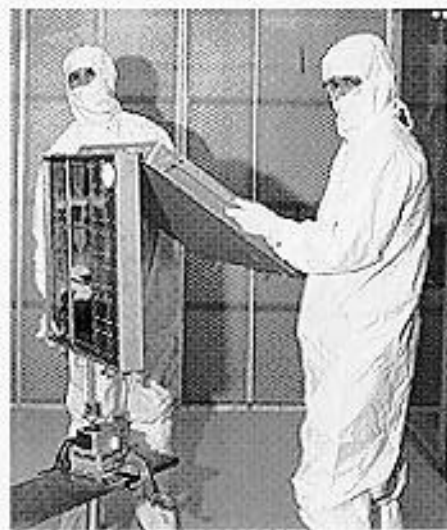
OPENING SEQUENCE FOR PEC'S

***Closed PEC in
launch & retrieval
configuration***

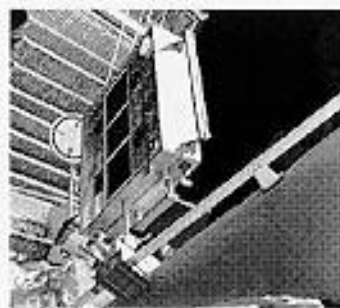
***Open PEC in
space exposure
configuration***
